Output Harmonics – HF Transmitter Fault Analysis

A survey of our members (North Cheshire Radio Club) in 2017 showed that no one could recall checking the output harmonics of their transmitters. I expect we are no exception in this respect, so why hasn't it brought Ofcom knocking on the door?

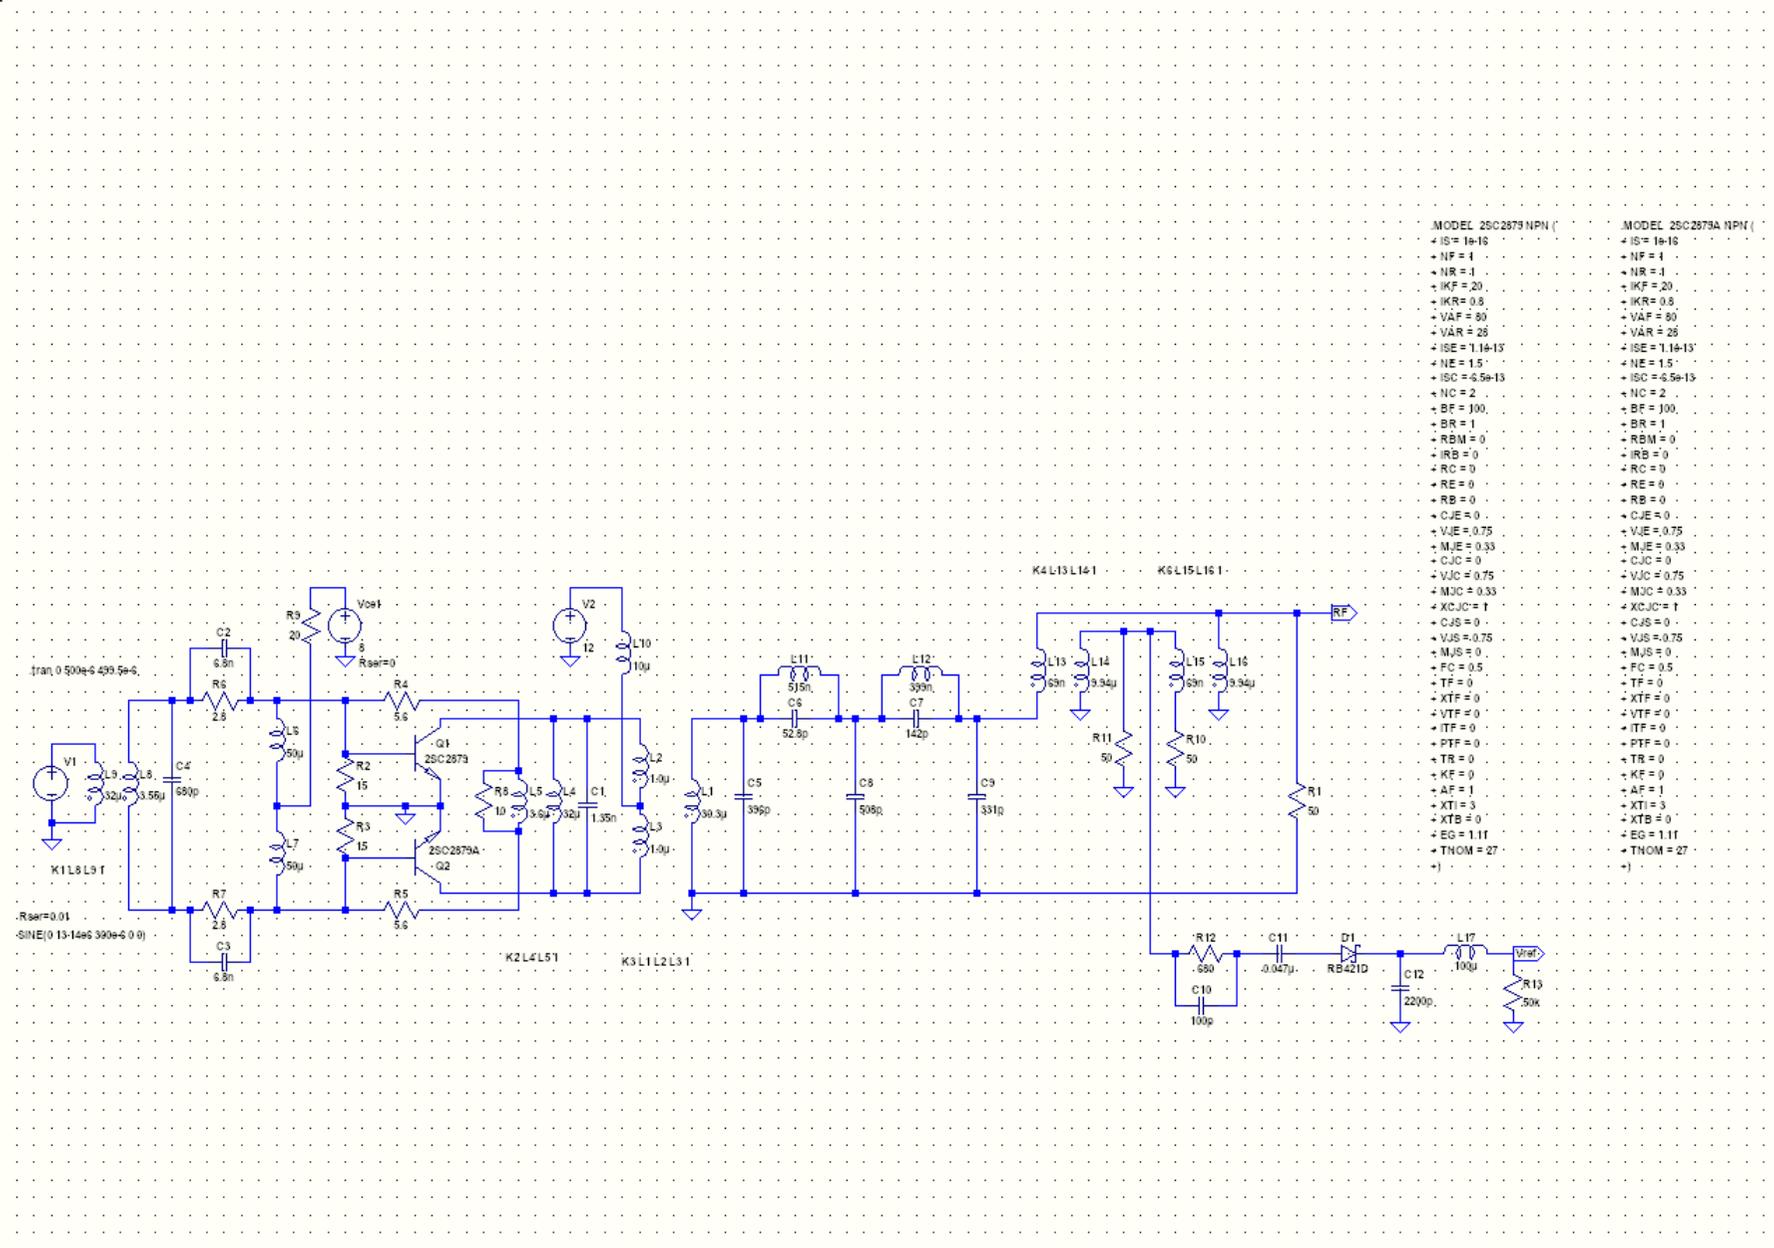
Figure 1 : Ltspice model of the TS-440 Transmitter Output stage.

In order to test the above hypothesis a fault analysis was carried out using a simulation of the output stages of a typical transmitter. The Kenwood TS-440 was chosen and modelled using LTspice – see Fig.1.

The circuit was stripped down to the basics, the following should be noted :-

- The simulations were run for 100 Watts output at 14MHz.
- The fundamental voltage and the harmonics were measured across a 50 Ω load, no ATU was used.

- There was no spice model available for the output transistors (2SC2879) which only had basic data sheets posted on the Internet. A generic transistor model was therefore used with the DC gain set to 100 (BF). The data was added twice to the schematic so that the effect of variations between the two transistor characteristics could be explored.

- The service manual gave values for the resistors and capacitors, but there were none for the inductors or the turn ratios for the matching and feedback transformers.

- The transformers were therefore based on the Motorola application note AN-762 for linear amplifiers.
 - The Cauer type low pass filter was derived from first principles using the Qucs filter design tool. The resulting capacitor values are similar but not identical to those in the TS-440 circuit.

- The VSWR circuit was incorporated as a check on the output matching circuit. The TS-440 circuit arrangement was used but the values were based on the bi-directional inline wattmeter by David Stockton G4ZNQ. Note: The TS-440 uses the reflected voltage signal to control the ALC to protect the transmitter from miss-matched antenna impedance by reducing the drive signal, but it does not protect against miss-matches caused by faults in the low pass filter circuit etc.
